Examining Puncture Resistance

Tests confirm ACI 302 recommendations for minimum vapor-retarder thickness

By Bruce A. Suprenant
and Ward R. Malisch

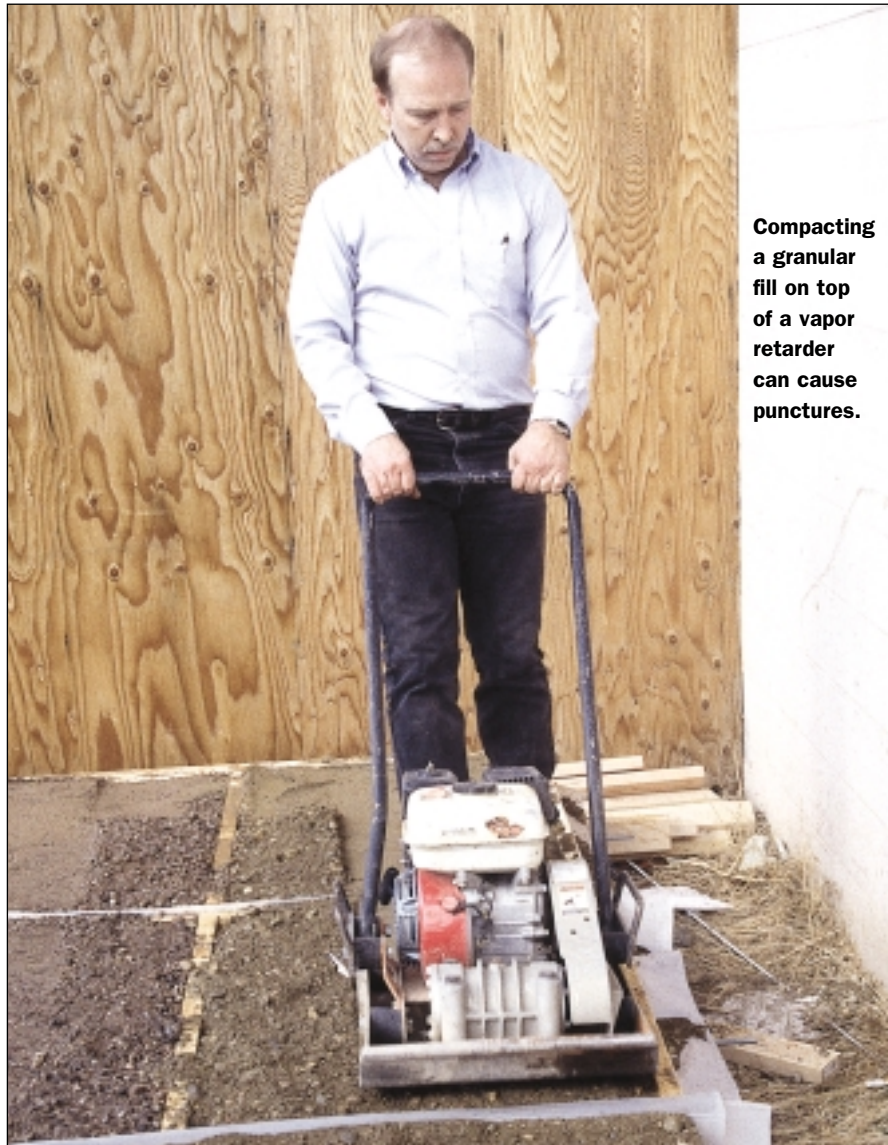
Compacting a granular fill on top of a vapor retarder can cause punctures.

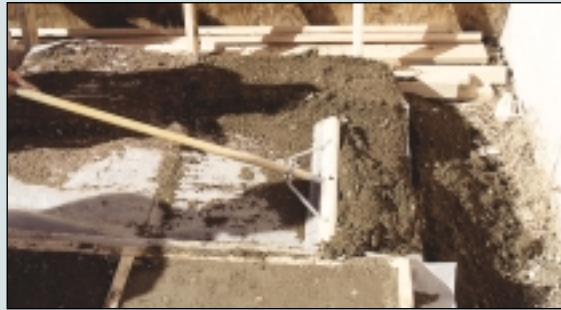
Before examining the vapor retarder for punctures, we carefully removed the fill with a broom.

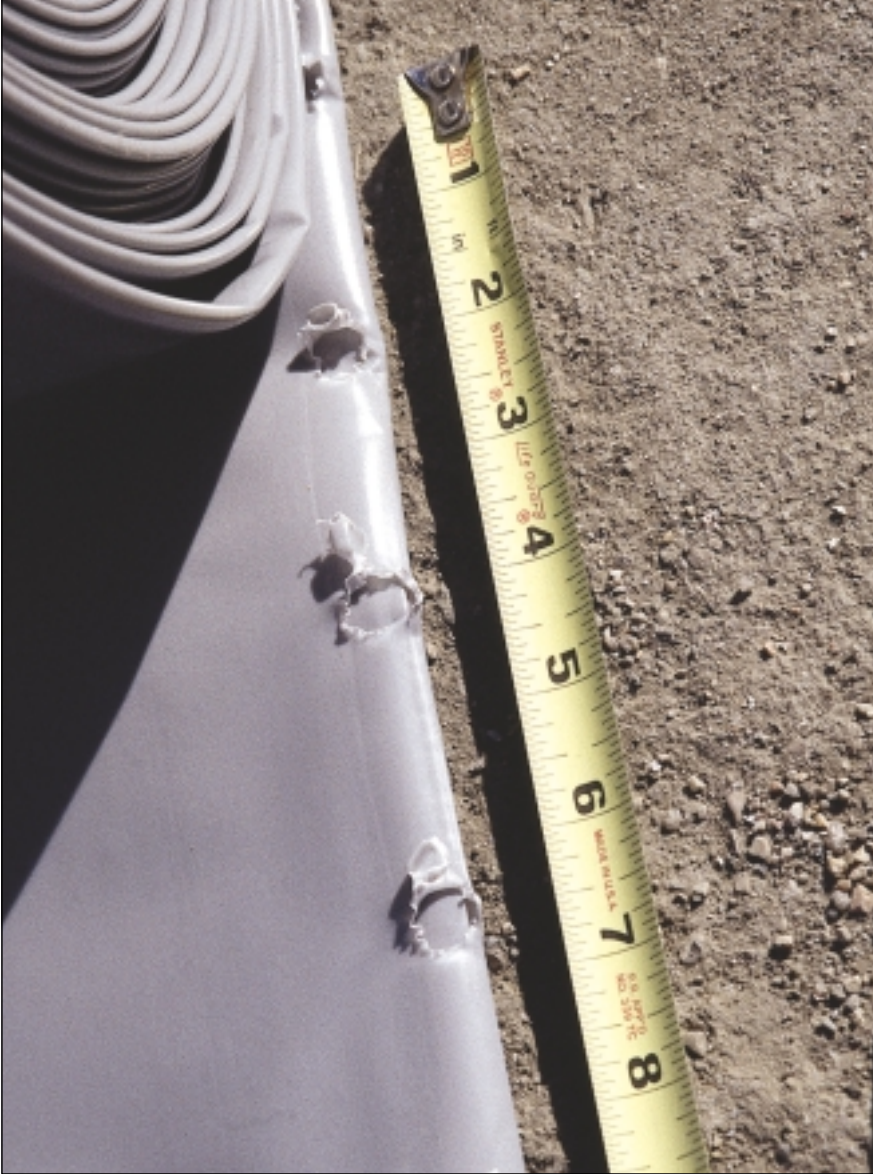
Left: This vapor barrier had been damaged before it was placed on the subbase. Below: Visual examination revealed the number of punctures caused by compacting granular fill on top of a vapor retarder.

fill material used. And, as expected, the number of punctures increased with decreasing vapor-retarder thickness (see table below).

Also as expected, fewer punctures occurred when rounded subbase and fill materials were used and more punctures occurred with angular materials. The ½-inch sand layer over the

vapor retarder, as might occur on a typical jobsite. Such traffic might cause more punctures than we got by simply compacting the fill. Thus, using the recommended 10-mil thickness, or greater, seems prudent.
