Examining Puncture Resistance

Tests confirm ACI 302 recommendations for minimum vapor-retarder thickness

By Bruce A. Suprenant
and Ward R. Malisch

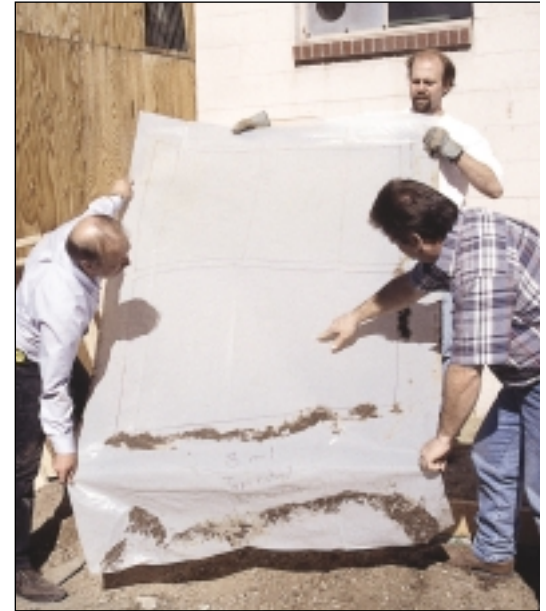
Left: This vapor barrier had been damaged before it was placed on the subbase. Below: Visual examination revealed the number of punctures caused by compacting granular fill on top of a vapor retarder.

We also found that construction operations may not be the only causes for punctures. The photo (above, left) shows 10-mil plastic sheeting that was damaged during manufacturing or shipping, resulting in larger holes than were produced by our puncture tests. ■
